Re: **Mr. Robert Eichenour Private Homeowner Construction Site; Construction Stormwater; SIC 1522; NPDES Compliance Evaluation Inspection; NPDES #NMU001987; February 27, 2019**

## NPDES Compliance Inspection Report

**Inspection Report: Clean Water Act Section 401 & 404**  
**La Canada Del Carro**  
**Surface Water Quality Bureau (SWQB)**  
**Watershed Protection Section**

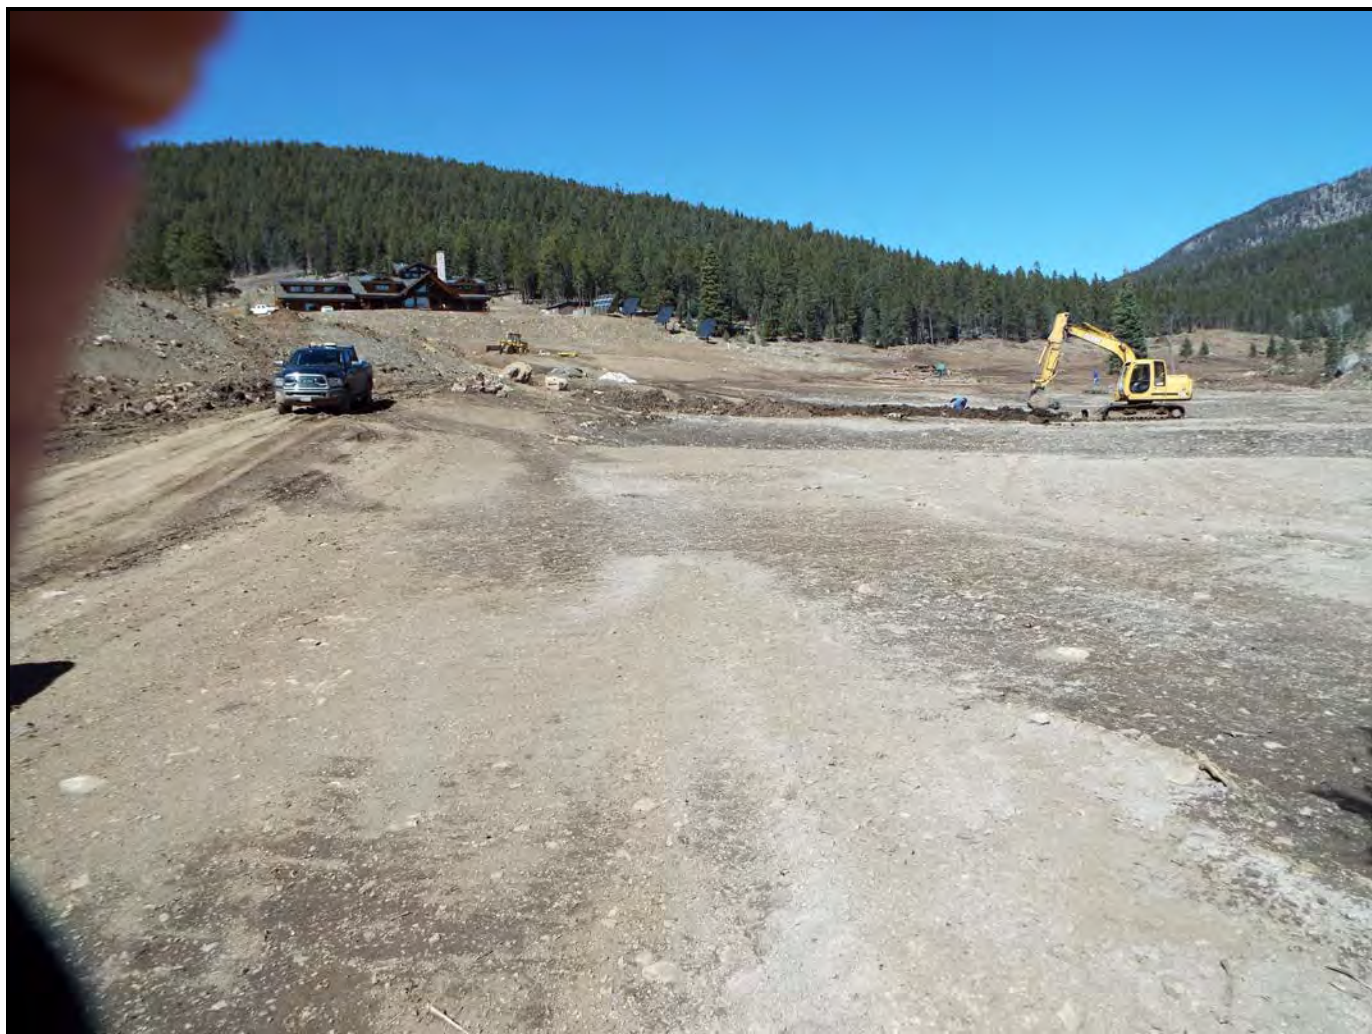
Photo # 1

Photographer: Daniel Valenta	Date: February 27, 2019	Time: 1221 hours
City/County: Guadalupita/Mora County		
Location: Canada del Oso Ranch, Canada del Carro Road, Guadalupita, New Mexico		
Subject: Canada del Oso Ranch house in the headwaters of the La Canada de Carro,

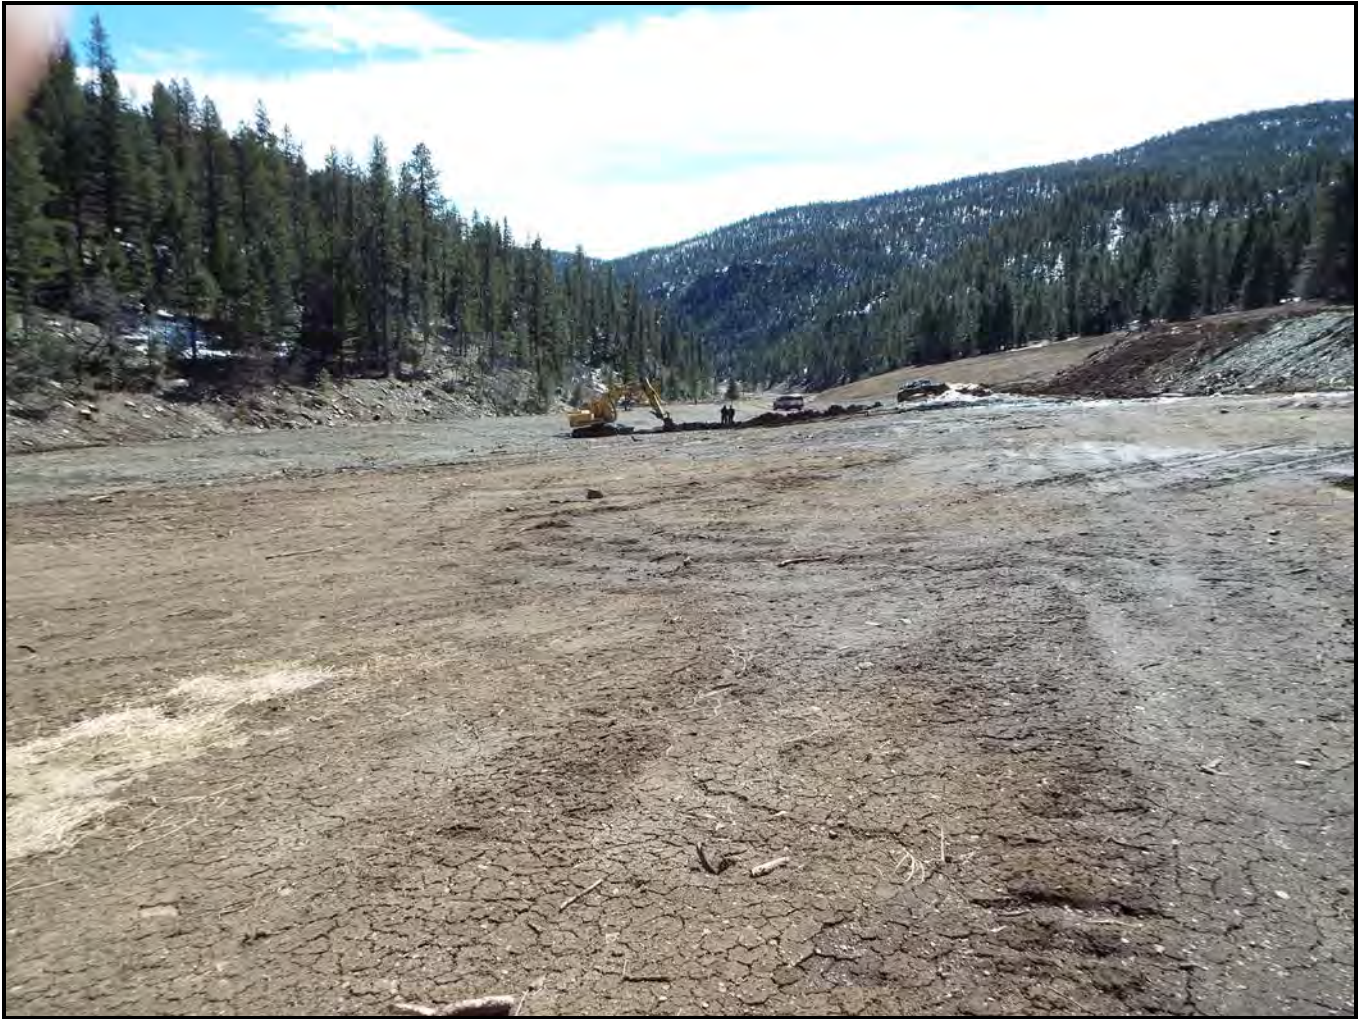
Photo # 2

Photographer: Daniel Valenta	Date: February 27, 2019	Time: 1216 hours
City/County: Guadalupita/Mora County		
Location: Canada del Oso Ranch, Canada del Carro Road, Guadalupita, New Mexico		
Subject: Looking downstream in the headwaters of the La Canada de Carro.

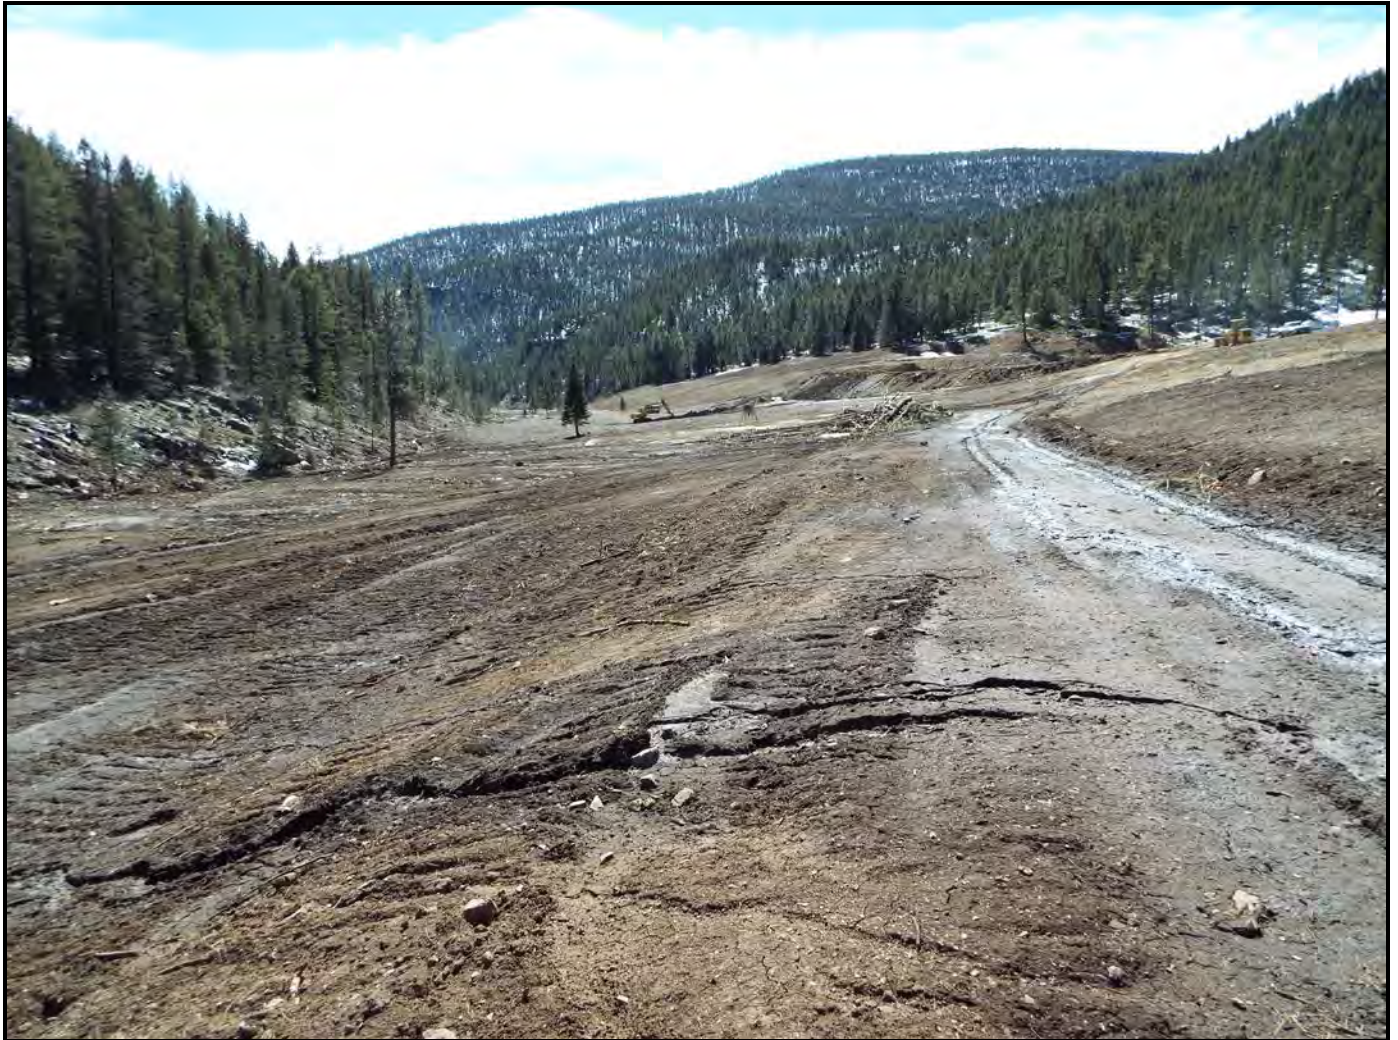
Photo # 3

Photographer: Daniel Valenta	Date: February 27, 2019	Time: 1212 hours
City/County: Guadalupita/Mora County		
Location: Canada del Oso Ranch, Canada del Carro Road, Guadalupita, New Mexico		
Subject: Looking downstream in the headwaters of the La Canada de Carro.

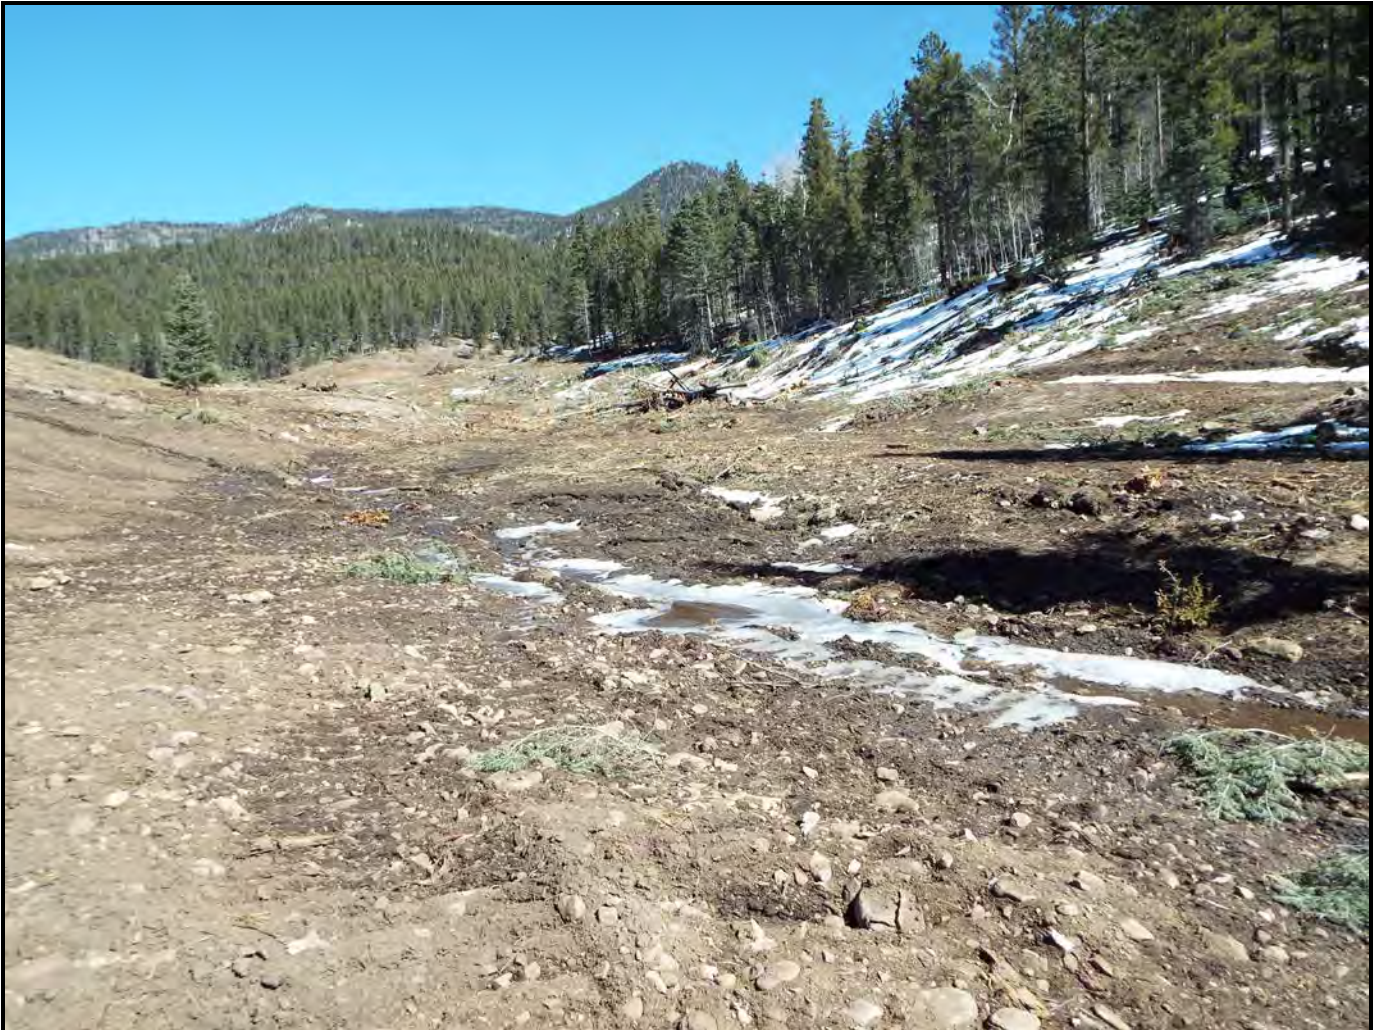
Photo # 4

Photographer: Daniel Valenta	Date: February 27, 2019	Time: 1147 hours
City/County: Guadalupita/Mora County		
Location: Canada del Oso Ranch, Canada del Carro Road, Guadalupita, New Mexico		
Subject: Looking upstream to the highest part of the clearing.

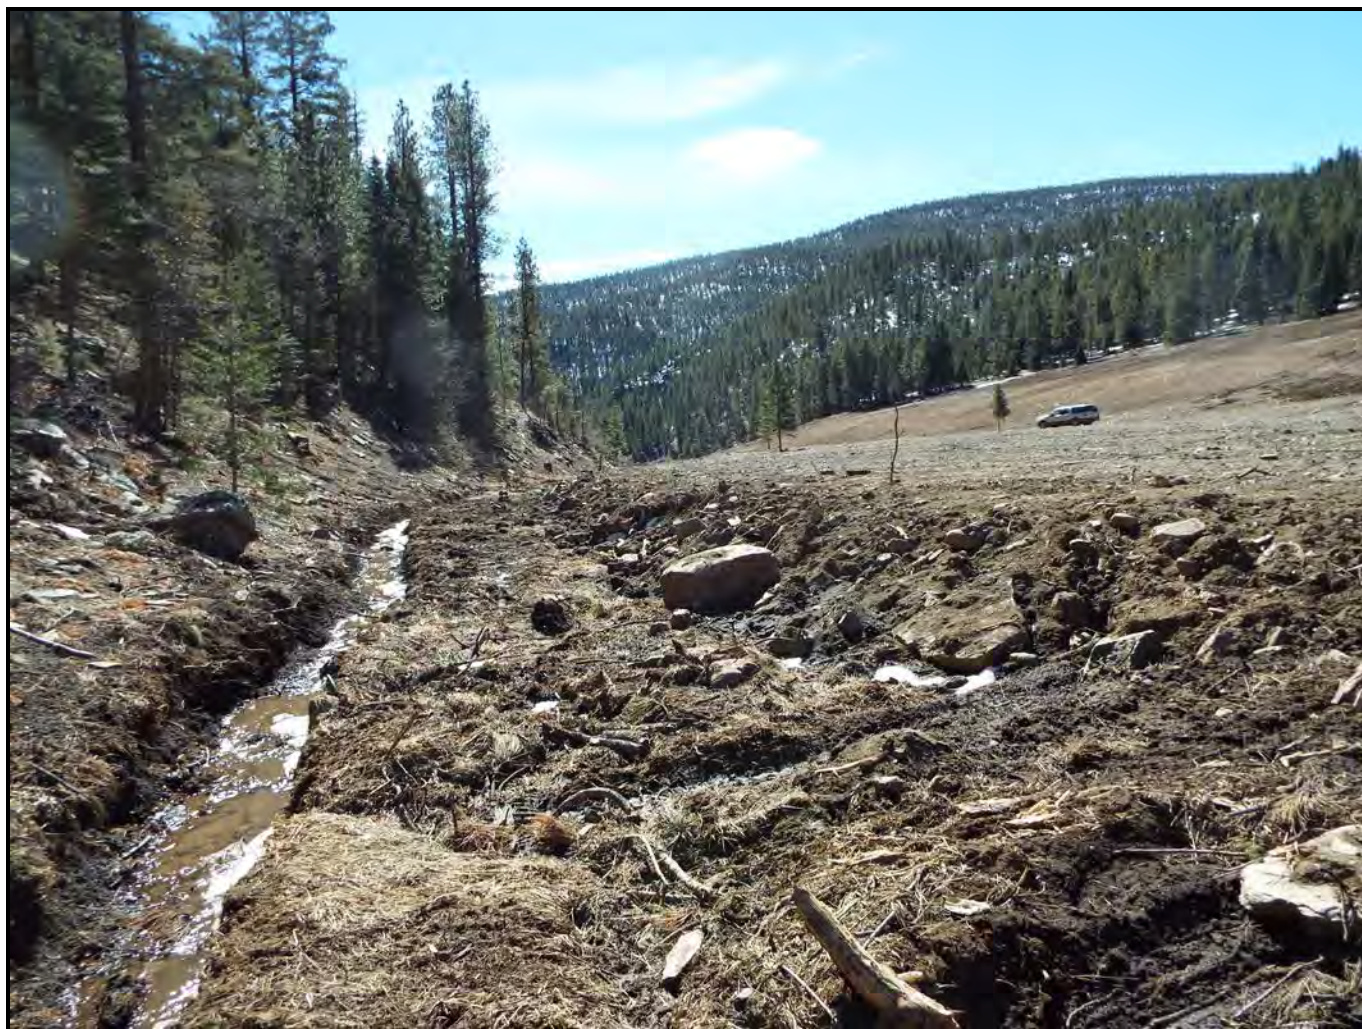
Photo # 5

Photographer: Daniel Valenta	Date: February 27, 2019	Time: 1140 hours
City/County: Guadalupita/Mora County		
Location: Canada del Oso Ranch, Canada del Carro Road, Guadalupita, New Mexico		
Subject: The La Canada del Carro was filled in and small wetlands covered. A new channel was dug to drain the area.

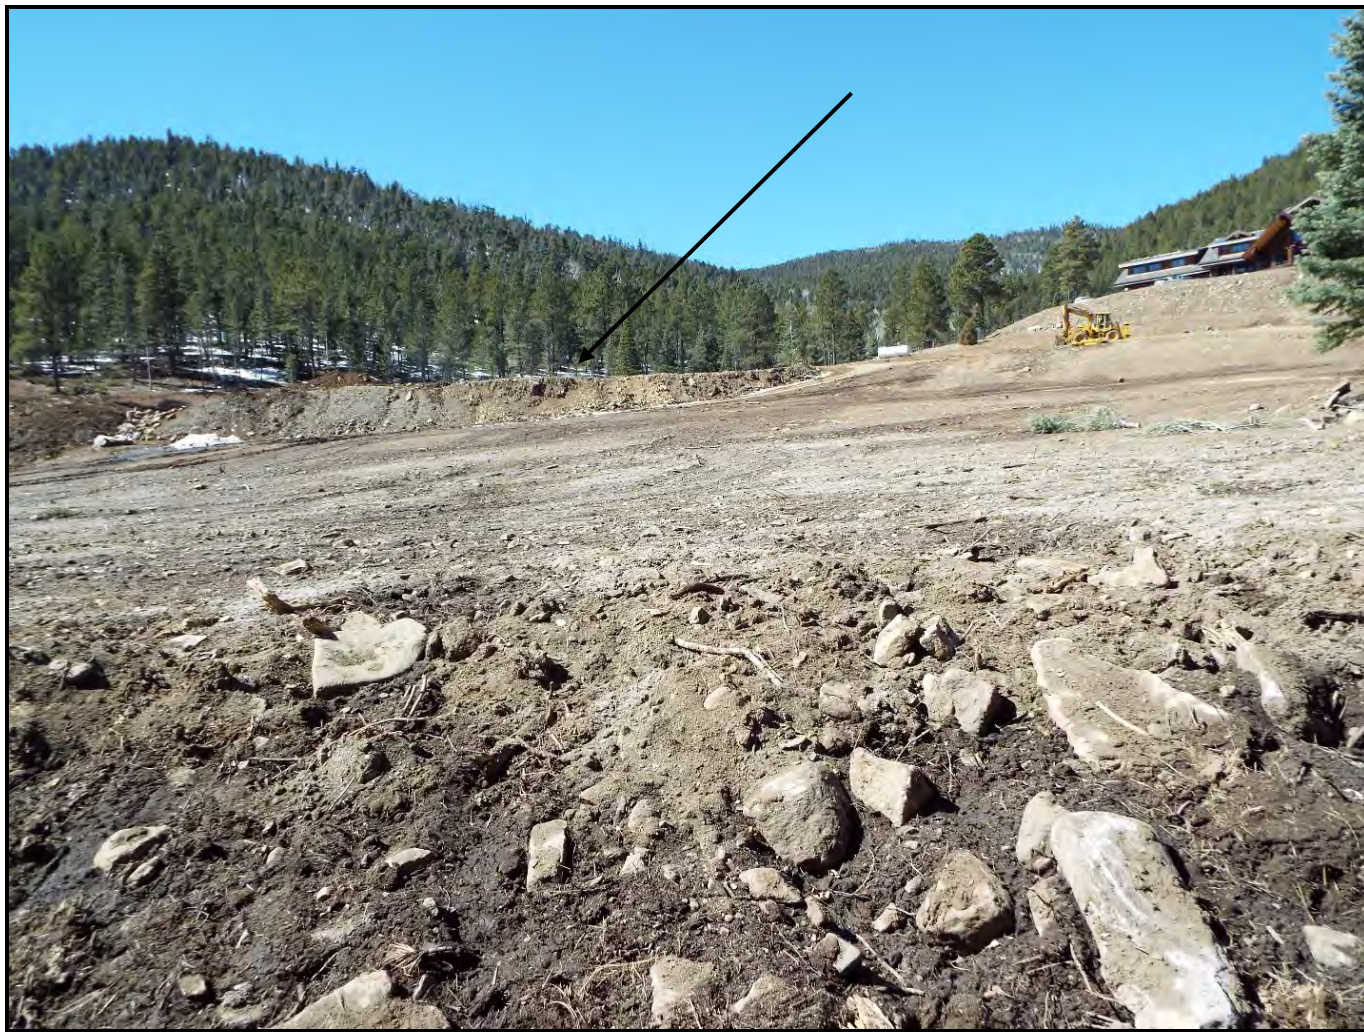
Photo # 6

Photographer: Daniel Valenta	Date: February 27, 2019	Time: 1140 hours
City/County: Guadalupita/Mora County		
Location: Canada del Oso Ranch, Canada del Carro Road, Guadalupita, New Mexico		
Subject: Holding pond was constructed.

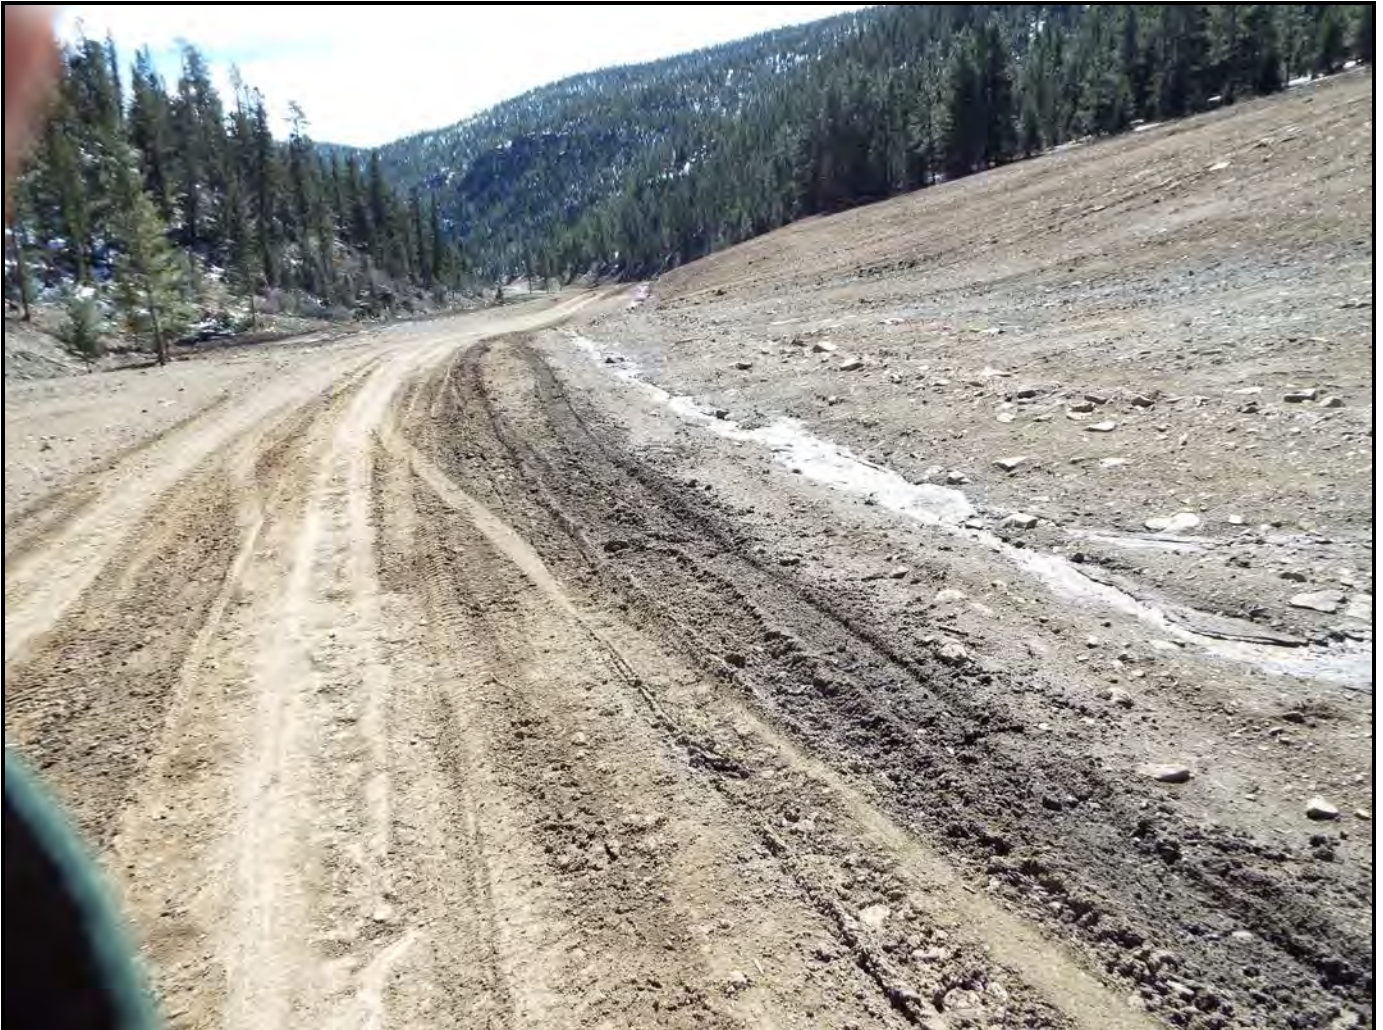
Photo # 7

Photographer: Daniel Valenta	Date: February 27, 2019	Time: 1221 hours
City/County: Guadalupita/Mora County		
Location: Canada del Oso Ranch, Canada del Carro Road, Guadalupita, New Mexico		
Subject: Road running downhill out of the valley.

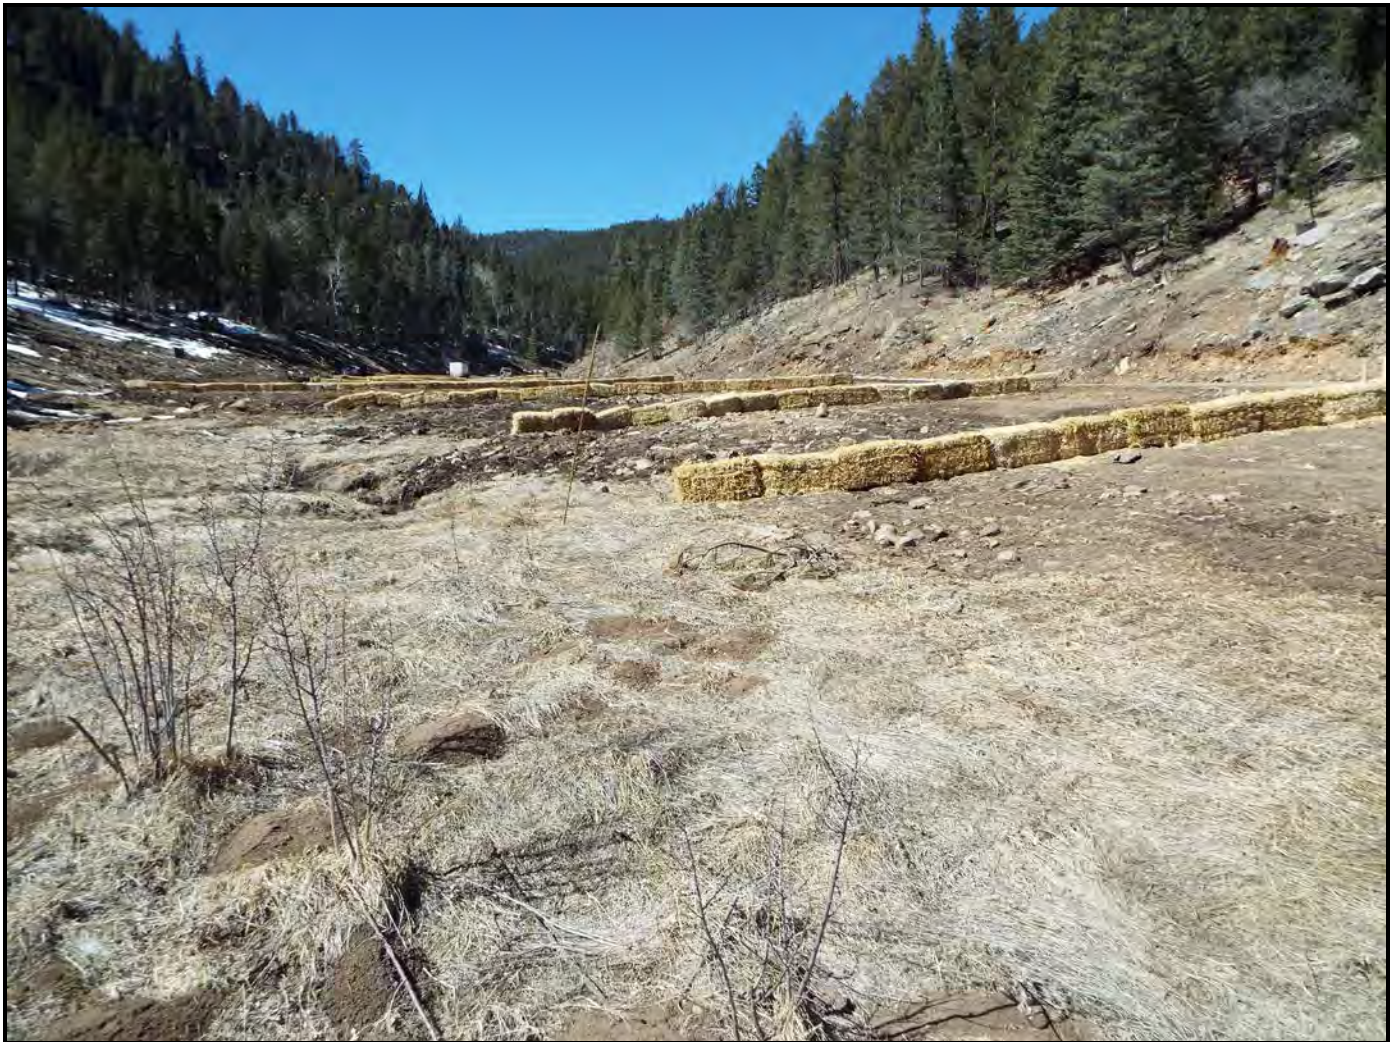
Photo # 8

Photographer: Daniel Valenta	Date: February 27, 2019	Time: 1234 hours
City/County: Guadalupita/Mora County		
Location: Canada del Oso Ranch, Canada del Carro Road, Guadalupita, New Mexico		
Subject: Entrance to the property, hay bales have been staked down.

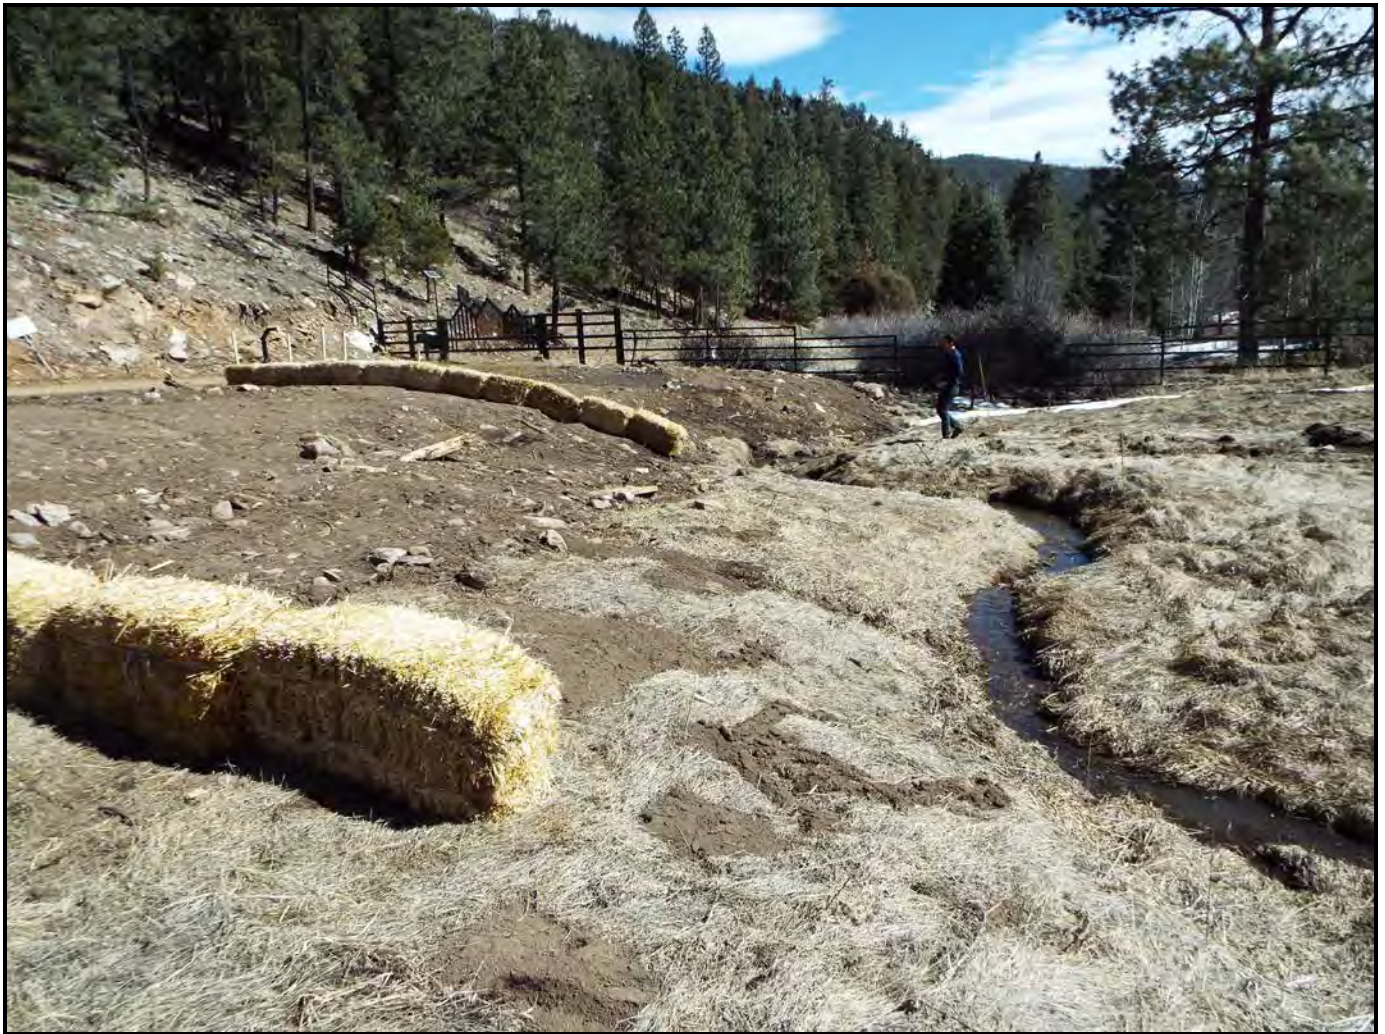
Photo # 9

Photographer: Daniel Valenta	Date: February 27, 2019	Time: 1234 hours
City/County: Guadalupita/Mora County		
Location: Canada del Oso Ranch, Canada del Carro Road, Guadalupita, New Mexico		
Subject: Entrance to the property, hay bales have been staked down. Note the undisturbed section of the La Canada del Carro.

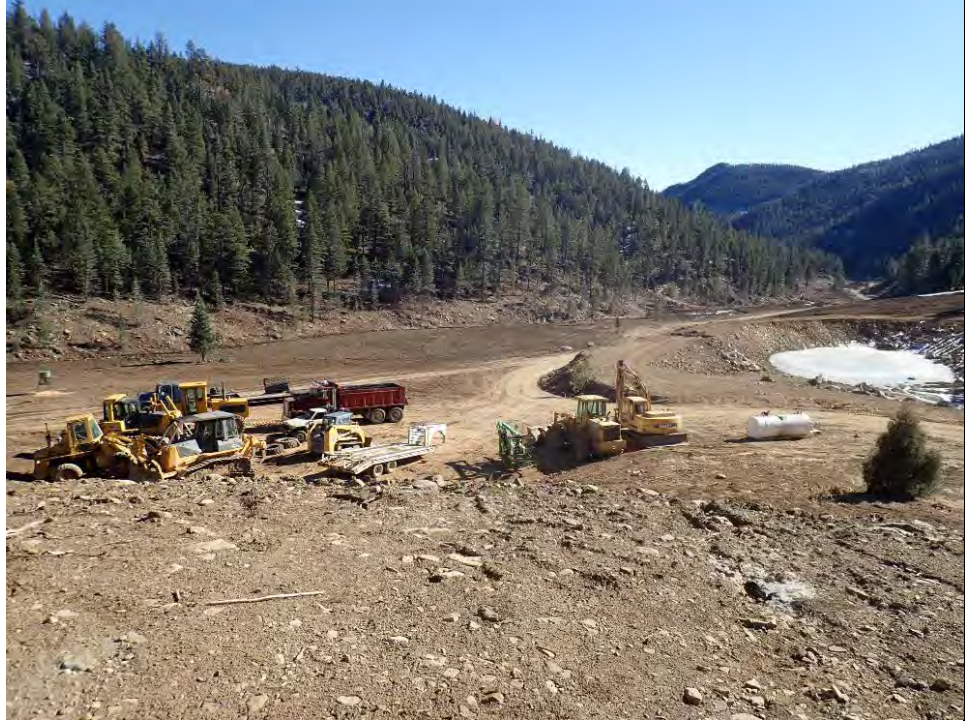
Photo 1

Looking south, down valley. The photo shows some of the heavy equipment that has been in operation. A pond captures surface flows from a small tributary to Canada del Carro. The mainstem of La Canada del Carro was relocated and straightened to the toe of valley left (looking down valley) – shown clearly in photos 10 and 11.

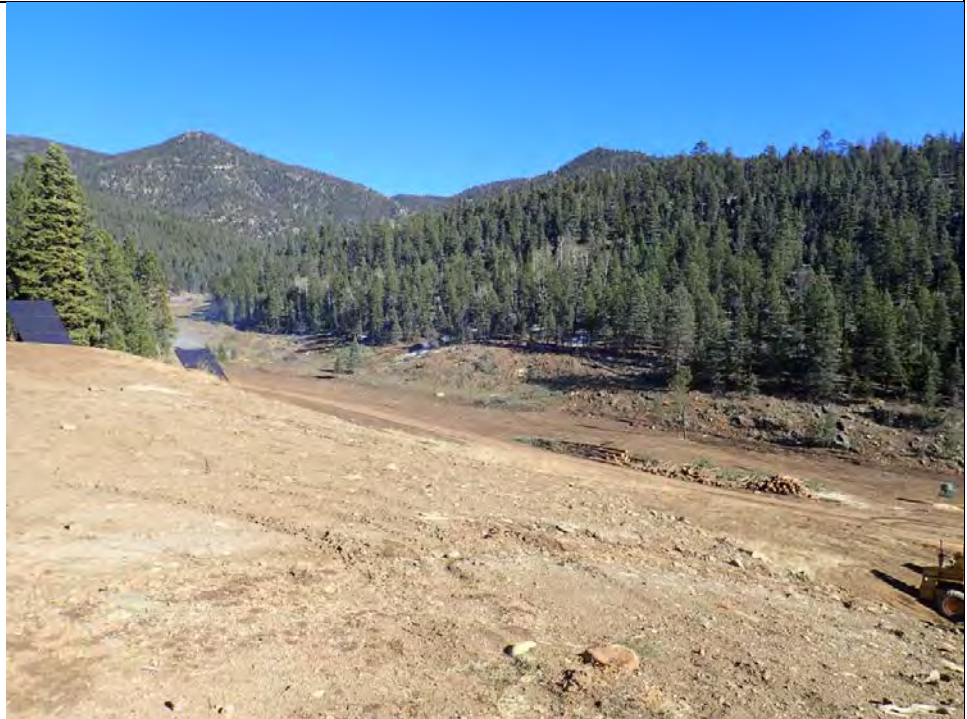
Photo 2

Looking northeast, up valley. A log landing can be seen next to a deer feeder. Extensive bare ground with no erosion control measures in place poses a significant risk to water quality.

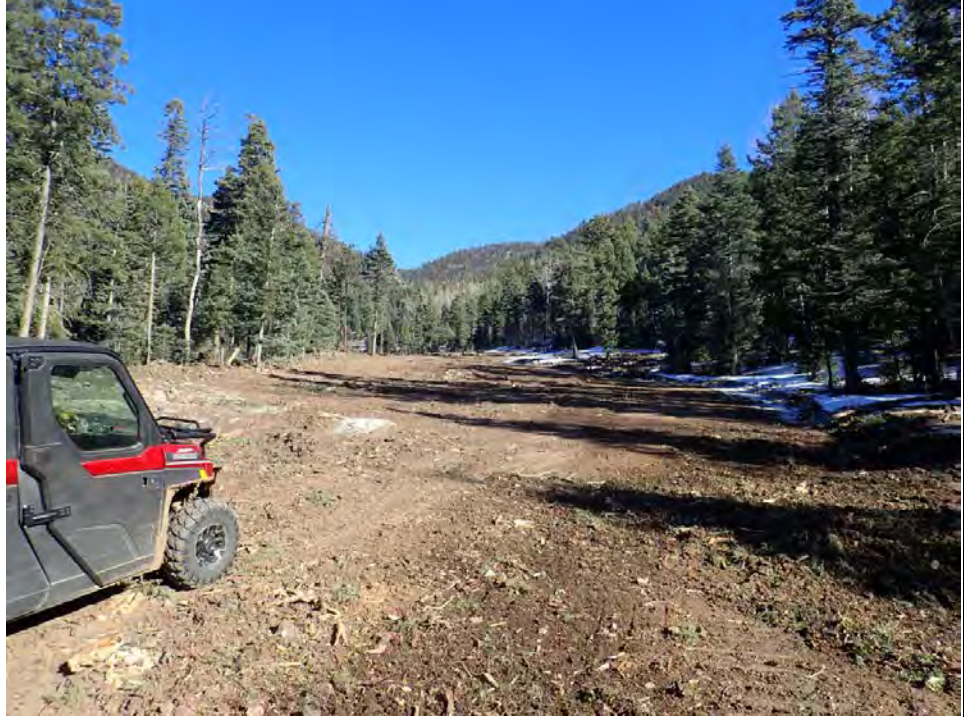
Photo 3

Looking northeast, up valley, at the upmost extent of the site visit. La Canada del Carro is on the photo left, just behind the tree line. The ground has been cleared and graded, material has been pushed into portions of the channel – see photos 5 through 8.

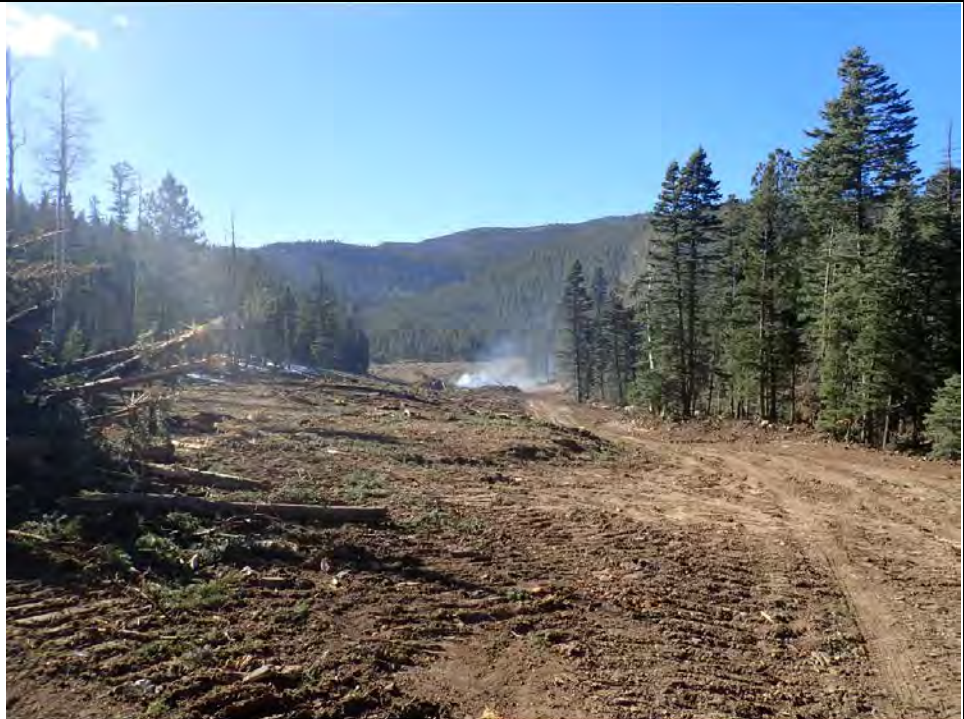
Photo 4

Looking southwest, down valley. Canada del Carro is in photo right, just behind the tree line. Multiple piles of slash were being burned throughout the valley.

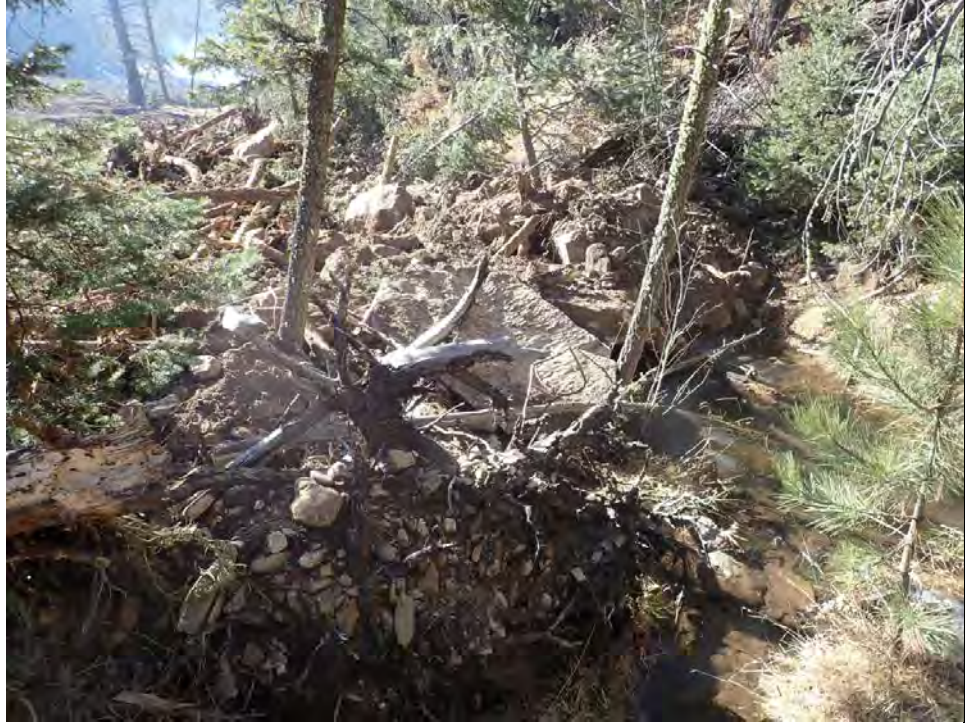
Photo 5

Rock, soil and tree debris was pushed across La Canada del Carro, blocking flows, and filling in the channel.

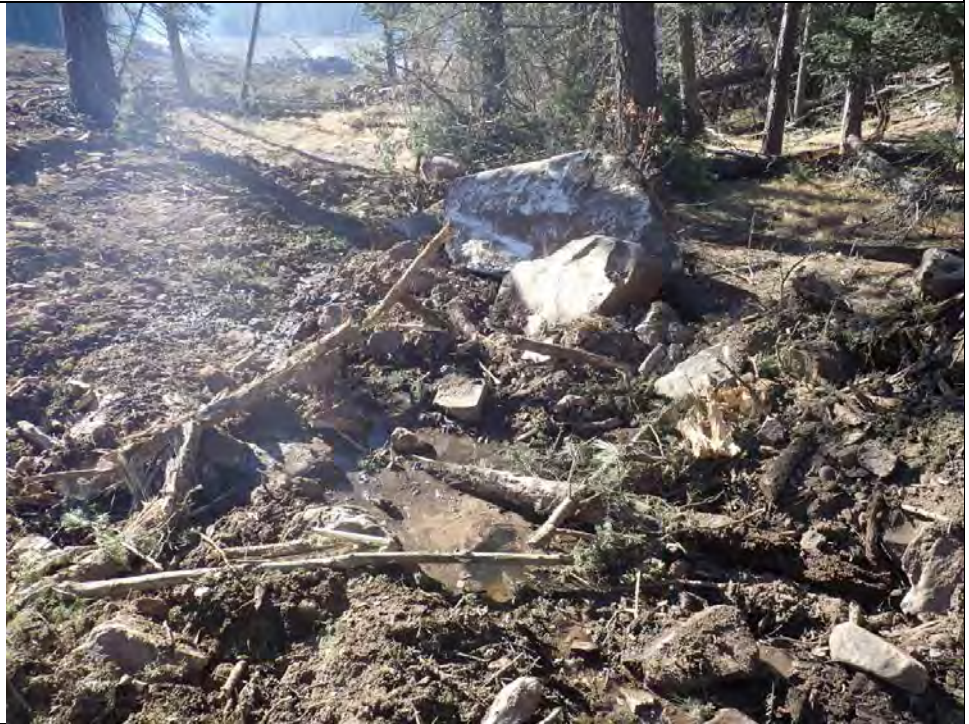
Photo 6

Additional rock, soil and tree debris was pushed across La Canada del Carro, blocking flows, and filling in the channel.

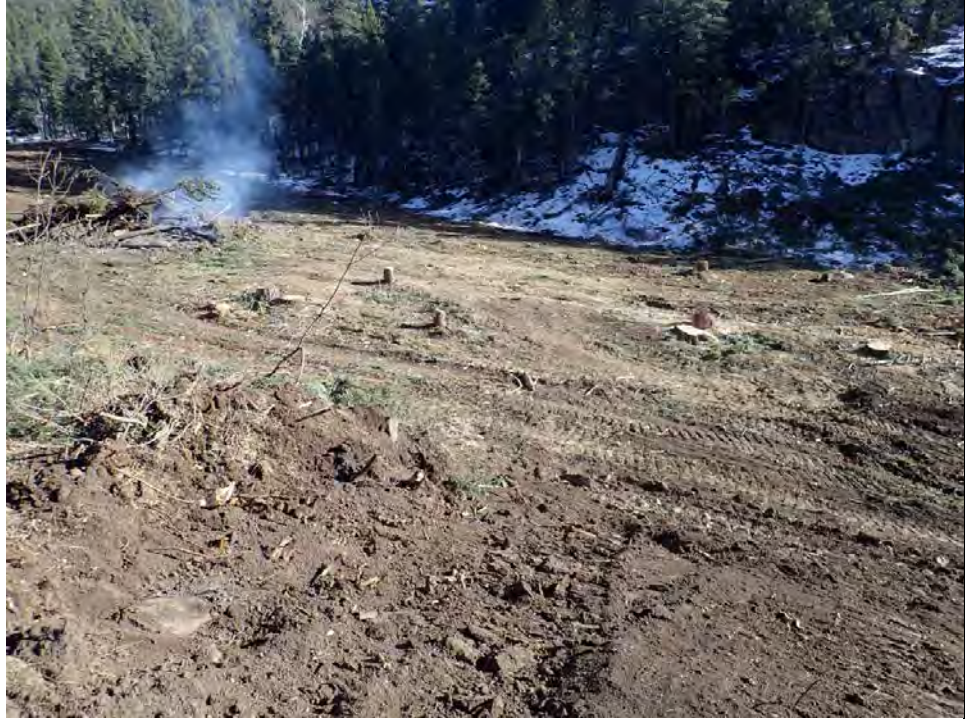
Photo 7

Looking east, across the valley. The channel originally crossed over from valley right to valley left in this location, but the channel had been graded over and was no longer identifiable.

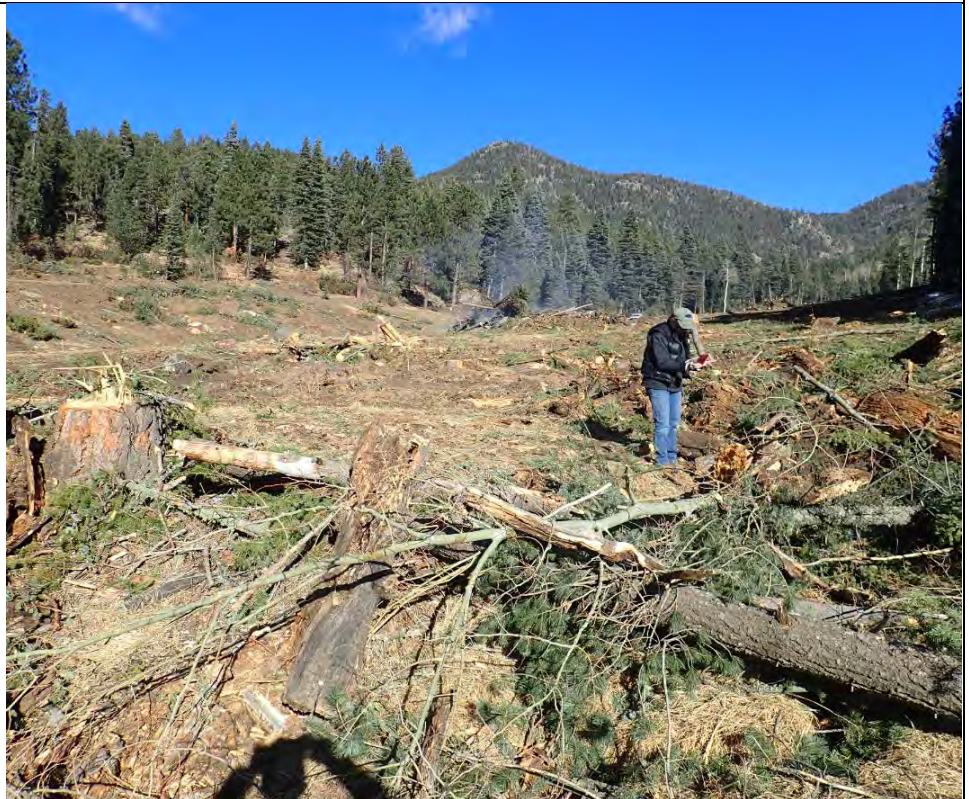
Photo 8

Looking up valley at timber slash that has completely filled and covered La Canda del Carro.

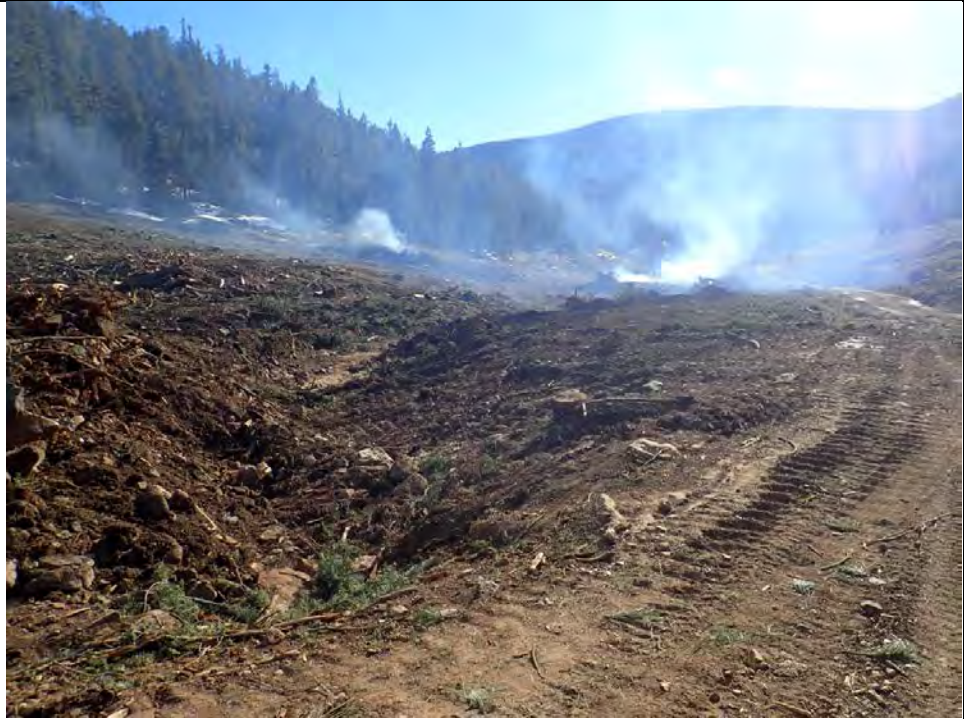
Photo 9

Looking down valley, over the west fork of La Canada del Carro at multiple piles of burning slash.

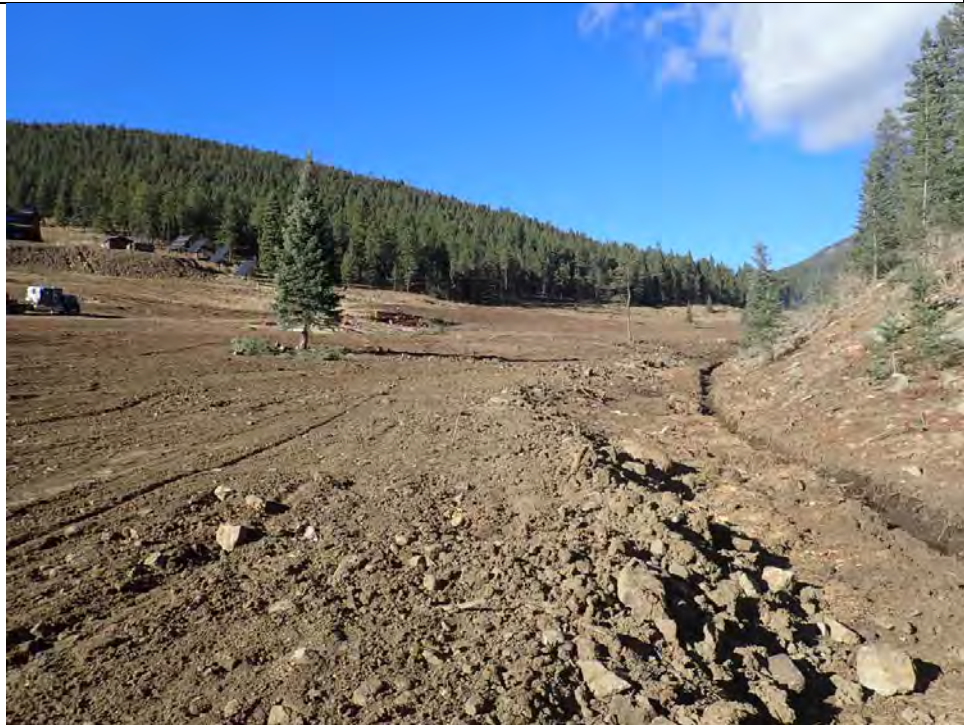
Photo 10

Looking up valley, Canada del Carro has been relocated to valley left and straightened.

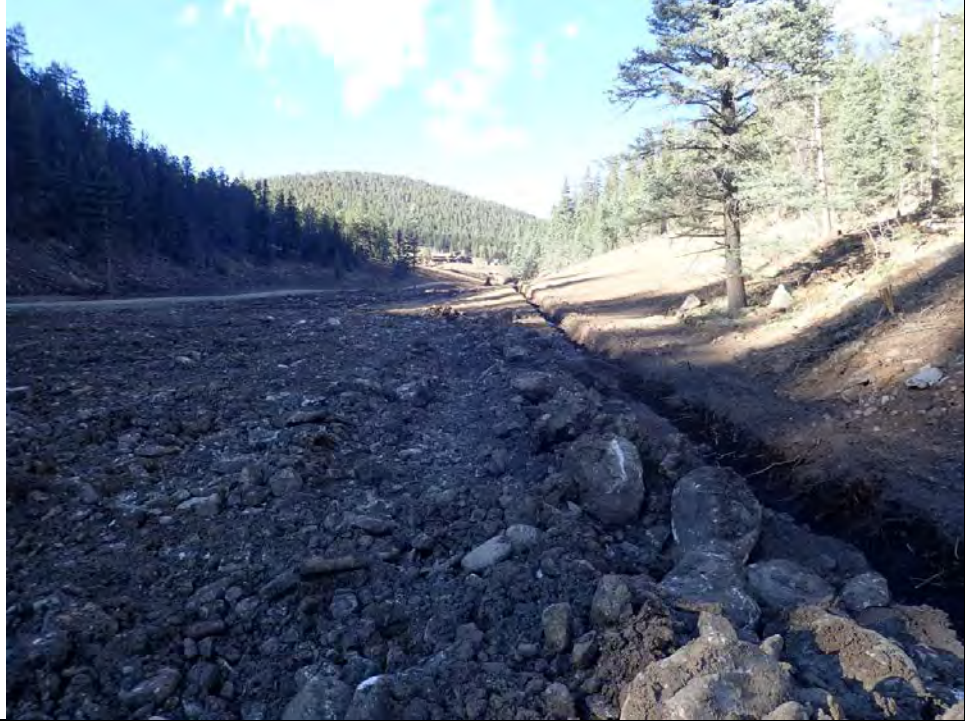
Photo 11

Looking up valley, approximately  $\frac{3}{4}$  of a mile of La Canada del Carro was relocated and straightened. With this straightened and steepened channel configuration that lacks bank and riparian vegetation, erosion will be a significant concern to water quality and designated uses.

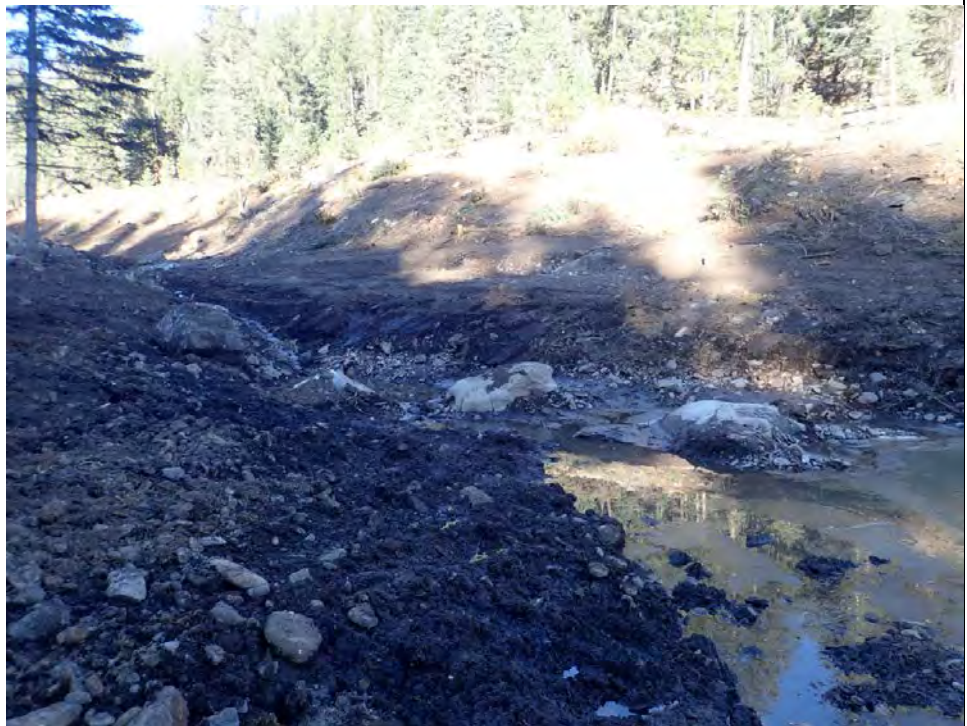
Photo 12

Top of a newly created pond located within La Canada del Carro.
